INDOOR AIR QUALITY ASSESSMENT

**Clement G. McDonough Arts Magnet School
40 Paige Street
Lowell, Massachusetts**

Prepared by:
Massachusetts Department of Public Health
Bureau of Environmental Health Assessment
January, 2001

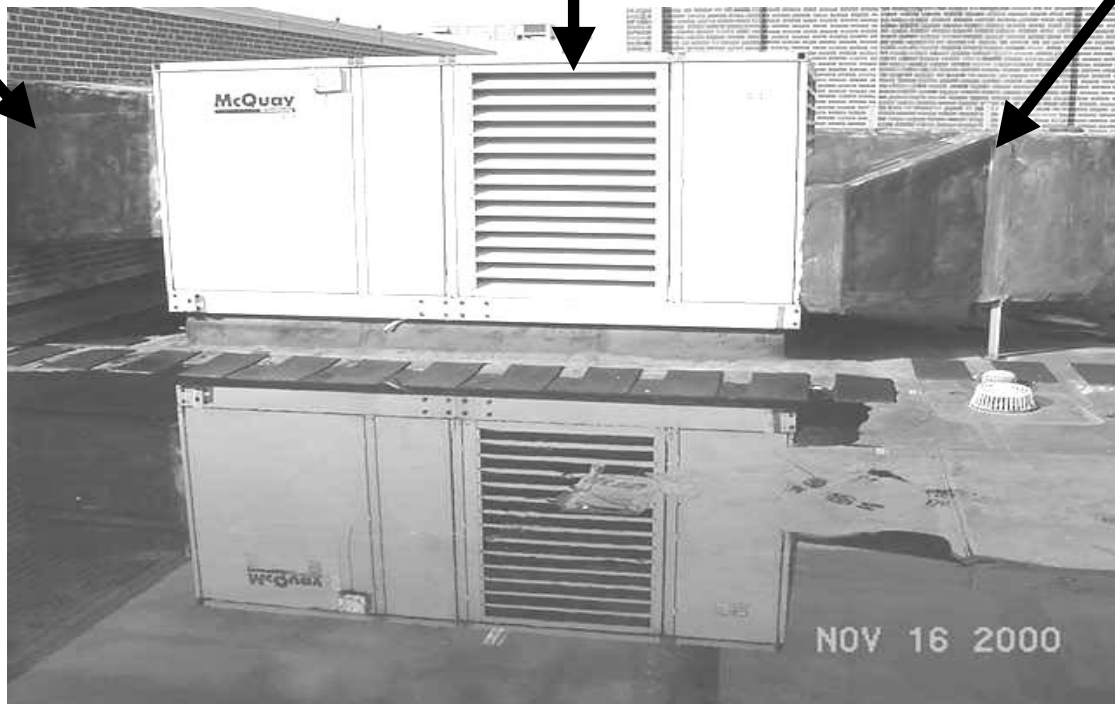
Picture 1

Ventilation is provided by a single AHU located on the roof of the “City” school (see Picture 1). Fresh air is distributed via ductwork connected to wall-mounted air diffusers in classrooms (see Picture 2). The amount of fresh air drawn into the units is controlled by moveable louvers connected to an activator motor that adjusts to alter fresh air intake to maintain temperature. The day of the assessment the AHU was shut down therefore no fresh air was being mechanically provided.

Standing water was noted in a number of areas on the roof, including under air handling equipment (see Picture 1). During operation of the AHUs, there is a potential for the entrainment of moisture into the HVAC system, which can lead to mold growth within the unit, and then in turn distributed to occupied areas via ductwork if activated. The collection of water and its subsequent freezing and thawing during winter months can lead to roof leaks resulting in water penetration into the interior of the building. Pooling water can also become stagnant, which can lead to mold and bacterial growth, resulting in unpleasant odors and providing a breeding ground for mosquitoes.

**AHU for “Arts” Magnet School Stationed on the Rooftop of the “City” Magnet School
Note Pooling Water below Fresh Air Intake**

5. Inspect roof for proper drainage; consider consulting a building engineer about possible options to eliminate water pooling on roof.
6. Repair/replace loose/broken windowpanes and missing or damaged window caulking building-wide to prevent water penetration through window frames.

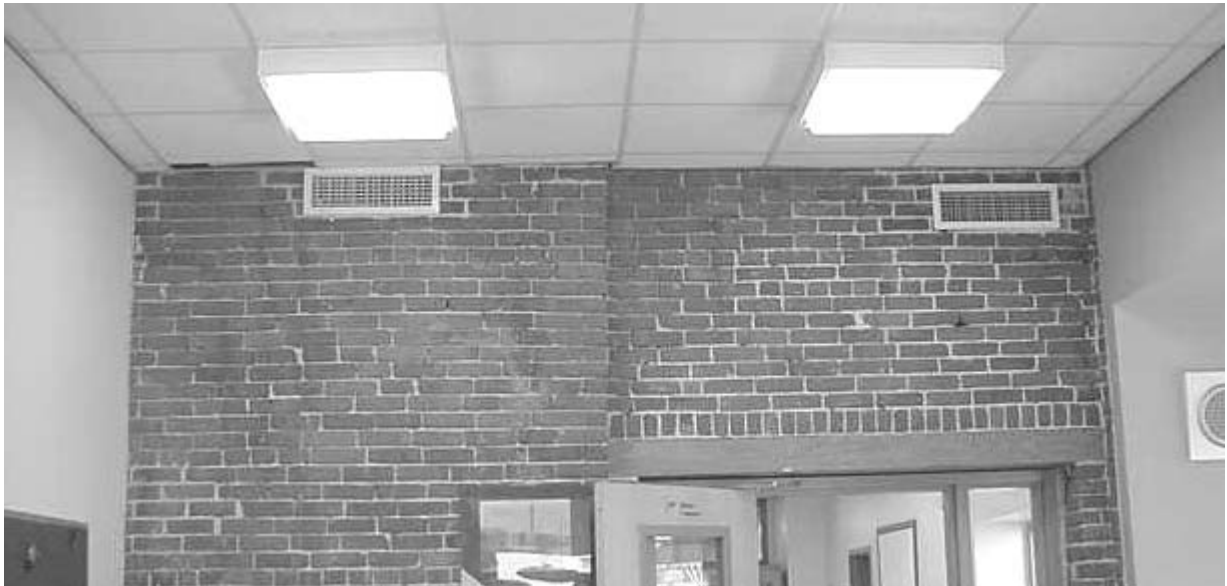
Picture 2

Exhaust ventilation is provided by wall-mounted grates (see Picture 2) that return air back to the AHUs via ductwork. It was reported by school officials that the AHU was deactivated over the summer of 2000 due to damage to the interior fiberglass lining of the AHU and ductwork, and that it has not been activated this school year. Without dilution and removal by the mechanical ventilation system, normally occurring environmental pollutants can build up and lead to indoor air quality and comfort complaints. BEHA staff examined the AHU and found both the exterior and interior insulation severely damaged (see Pictures 3-6).

Example of Typical Supply and Return Air Diffusers

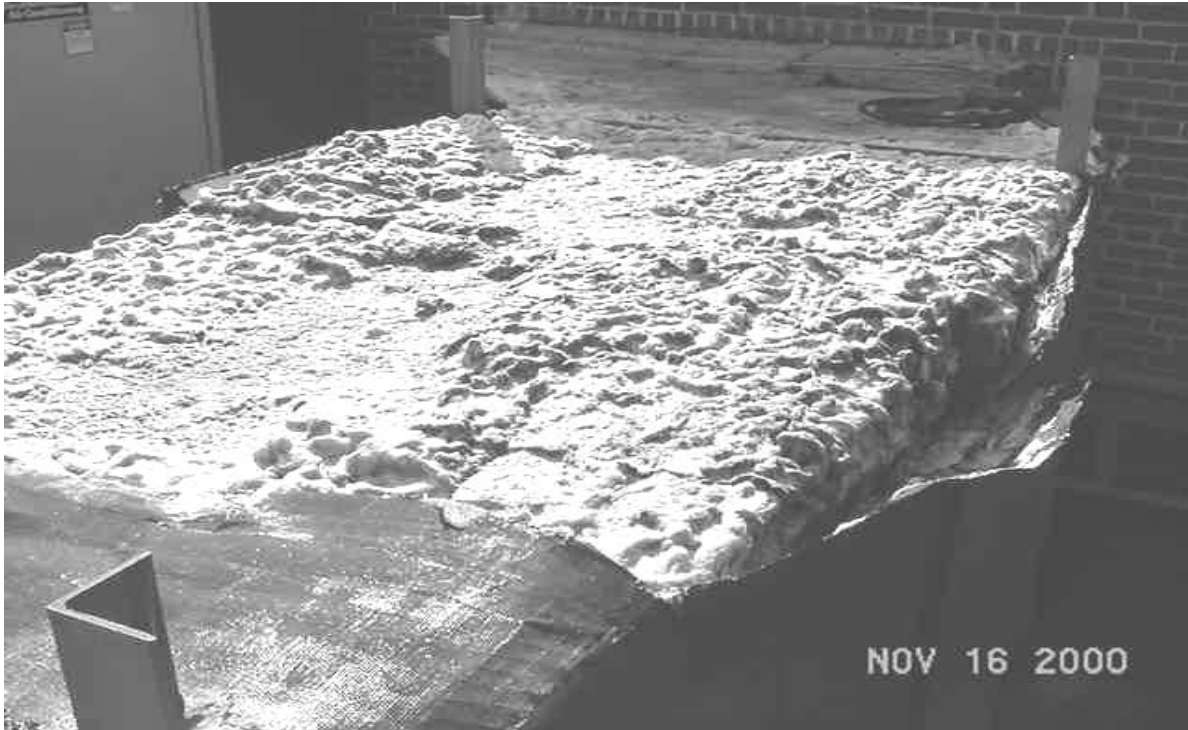
Picture 3

Damaged Exterior Ductwork Insulation Note Liner is Splayed Exposing Insulation Material

- 1) Hire an HVAC engineering firm to evaluate the ventilation system. **Do not activate HVAC system until damaged ductwork and interior lining of the AHU is repaired/replaced.**

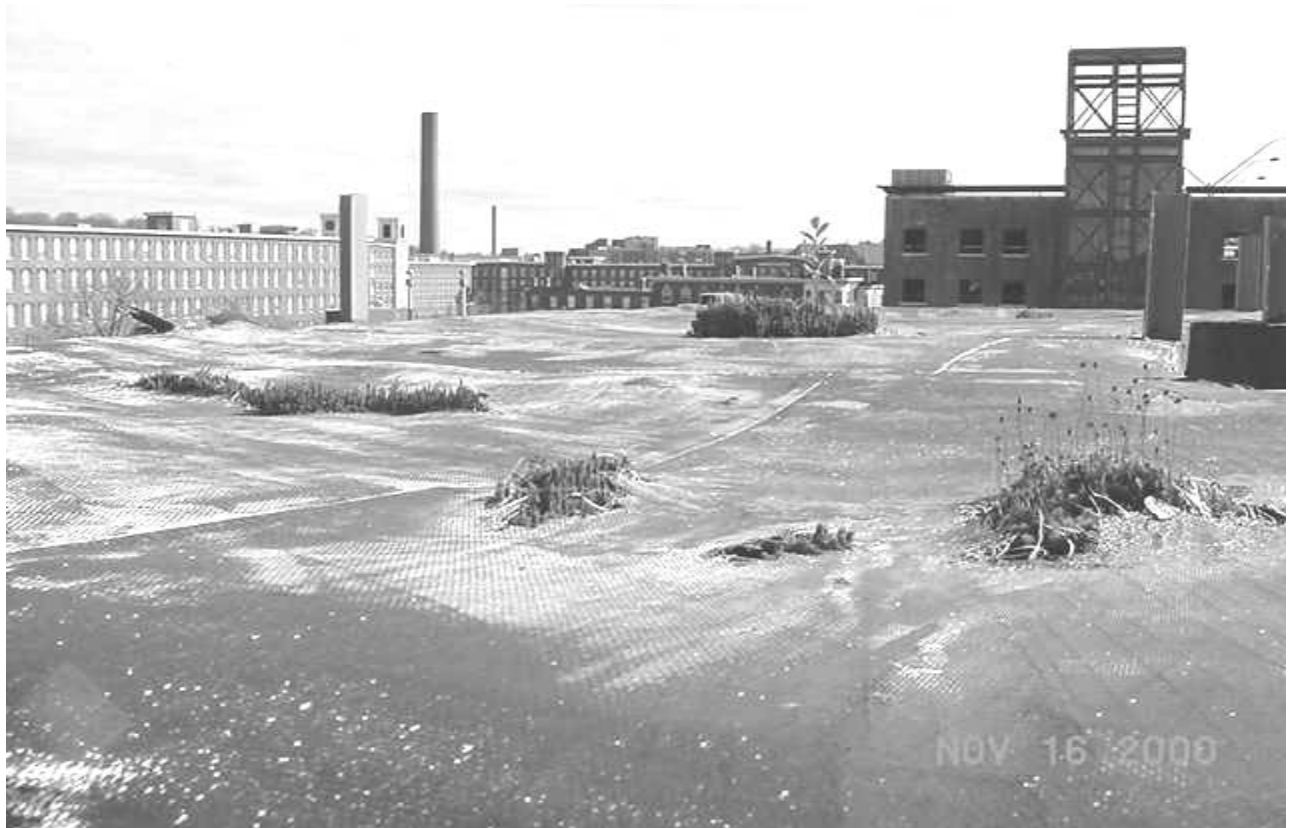
Picture 4

Plant Growth Protruding from Damaged Ductwork Insulation

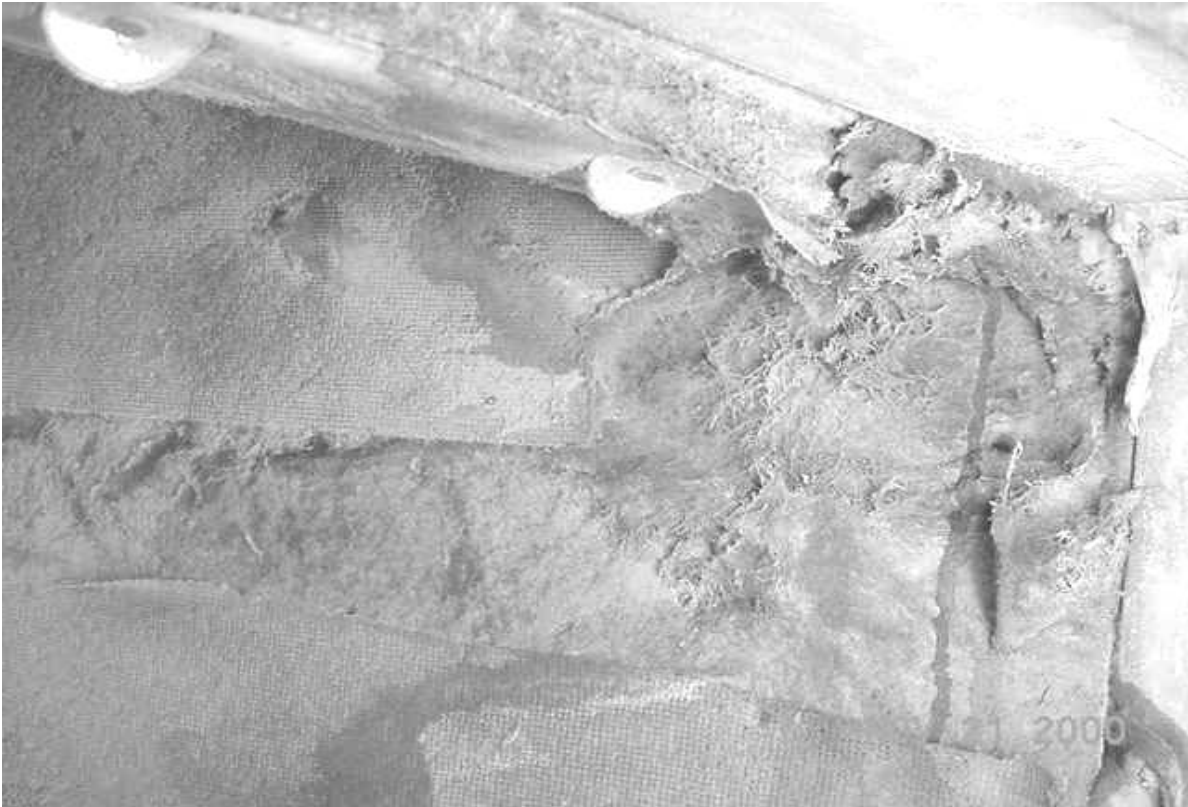
Picture 5

Damaged Insulation Observed in Interior of Ductwork

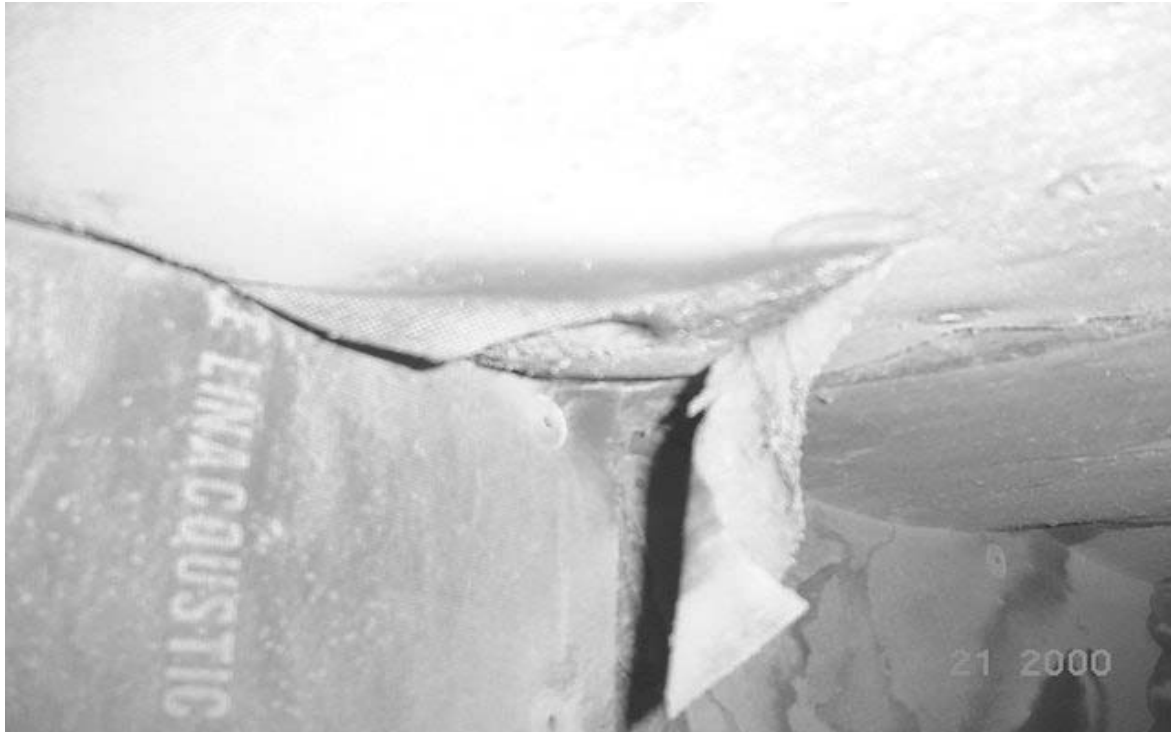
Picture 6

Damaged Insulation Observed in Interior of Ductwork

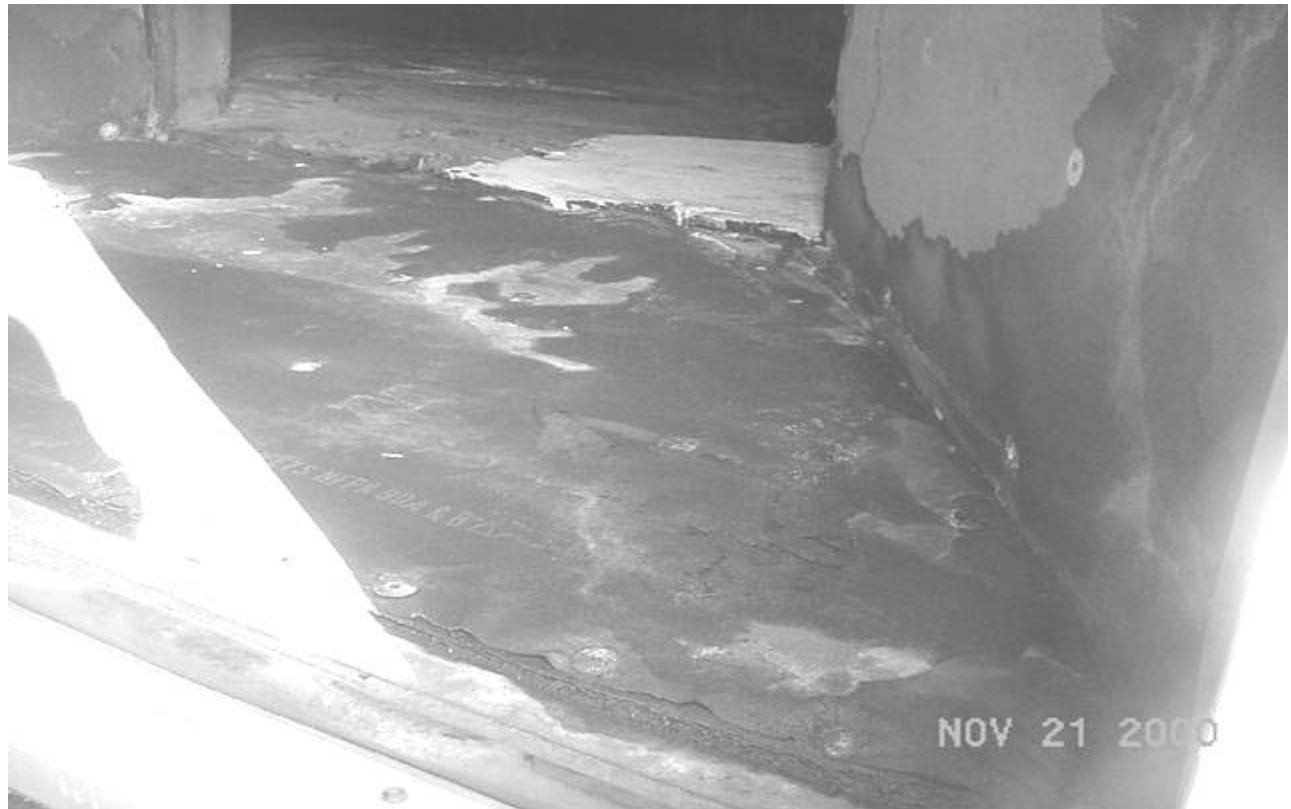
Picture 7

BEHA staff examined the interiors of the AHU and accessible ventilation ductwork. The AHU and its ductwork are lined with fiberglass insulation. The interior of the AHU was inspected and was found saturated with evidence of possible microbial

**Water Damaged Interior Lining of Ductwork Insulation
Moisture Content Readings in This Area Measured 99.9 % indicating Saturation**

- 2) If fiberglass liner of AHU and/or ductwork is replaced the interior of the AHU should be vacuumed out, cleaned with an appropriate antimicrobial, and allowed to completely dry before operation.

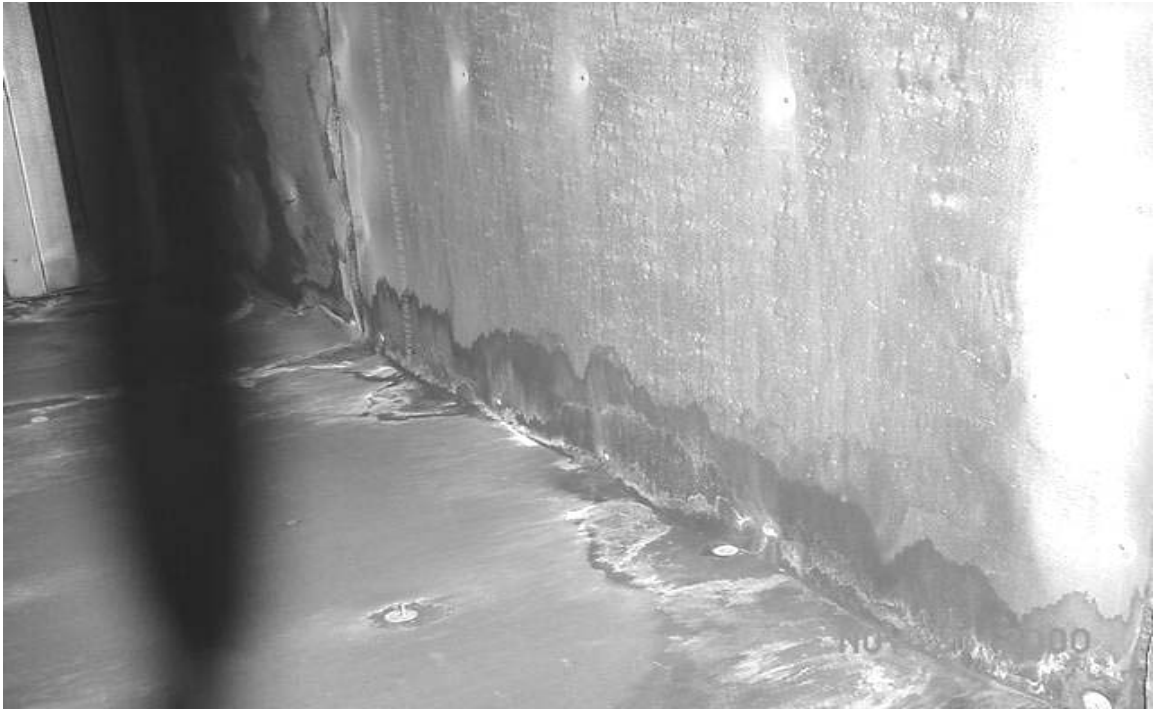
Picture 8

growth (see Picture 7). Rooftop ductwork had visible water damage to the top, sides and bottom of the interior lining of ductwork insulation (see Pictures 8 & 9). Moisture measurements were taken in the AHU and duct insulation where accessible. These measurements and observed damage indicate that the watertight integrity of the ductwork has been breached. Moisture readings in insulation ranged from 8.2 percent to a peak of 99.9 percent.

Water Stains along Bottom/Side of Interior Ductwork Insulation

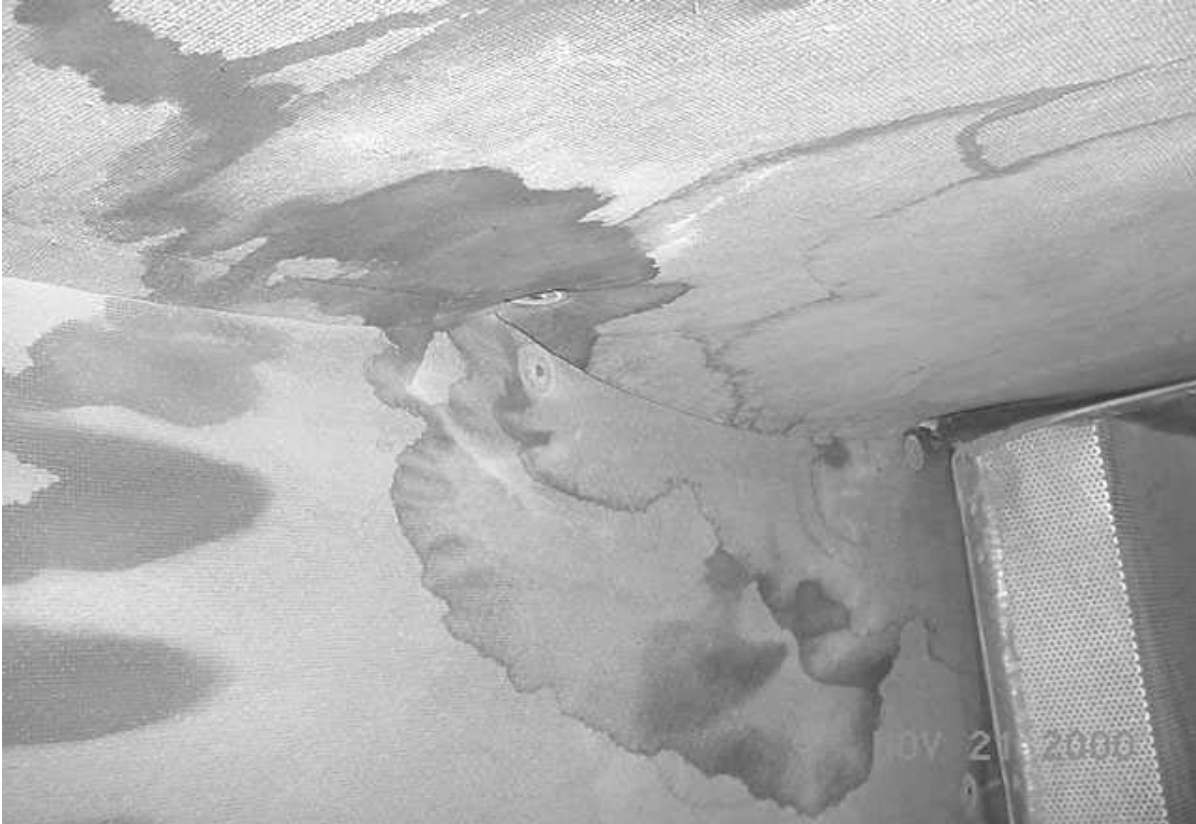
Picture 9

Water Stains along Top/Side of Interior Ductwork Insulation

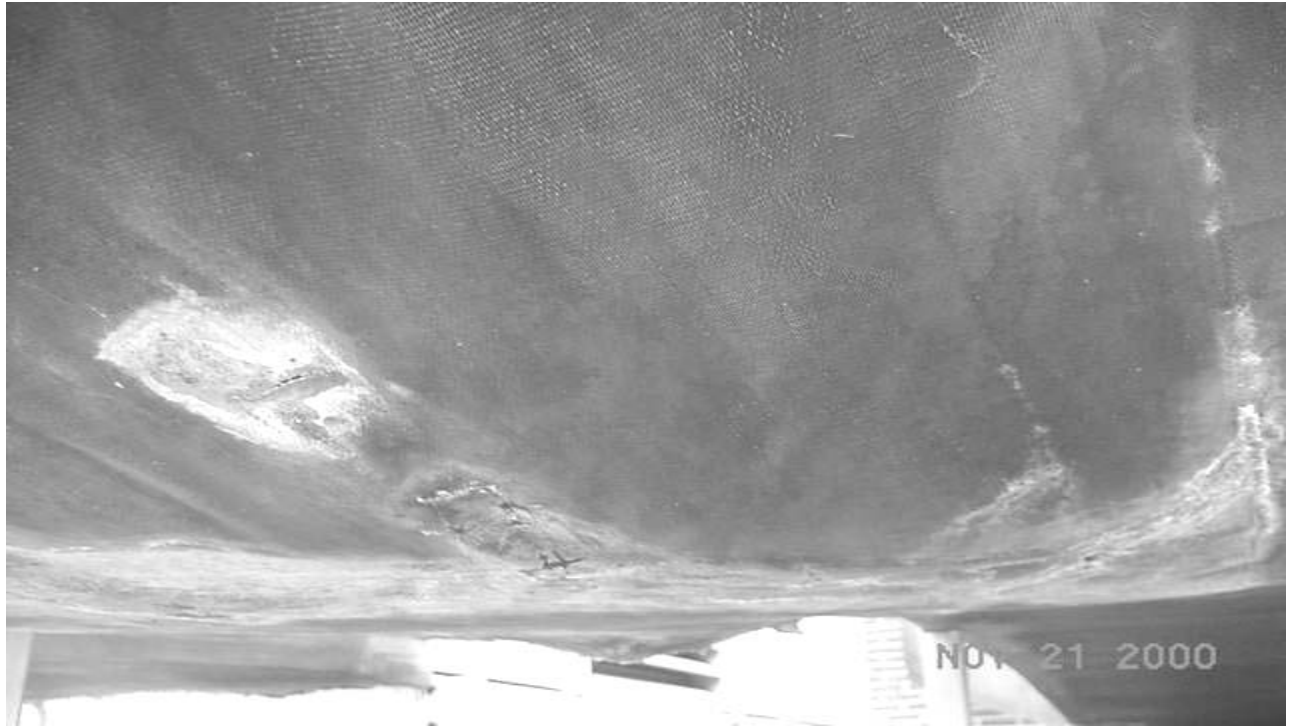
Picture 10 shows the condition of the bottom of ductwork, which appears to have “bowed” due to the increased weight of the saturated ductwork liner/insulation. Below this area was a pile of wet fiberglass material, which appears to have come from the inside of the unit (see Picture 11) further indicating that the integrity of the ductwork has been compromised. Fiberglass is a porous material, which provides a medium for mold and mildew growth when it becomes repeatedly moistened. Mold growth inside an air-handler/duct work can be distributed to occupied areas via the ventilation system, if activated.

Underside of Ductwork Note Torn Water Damaged Liner

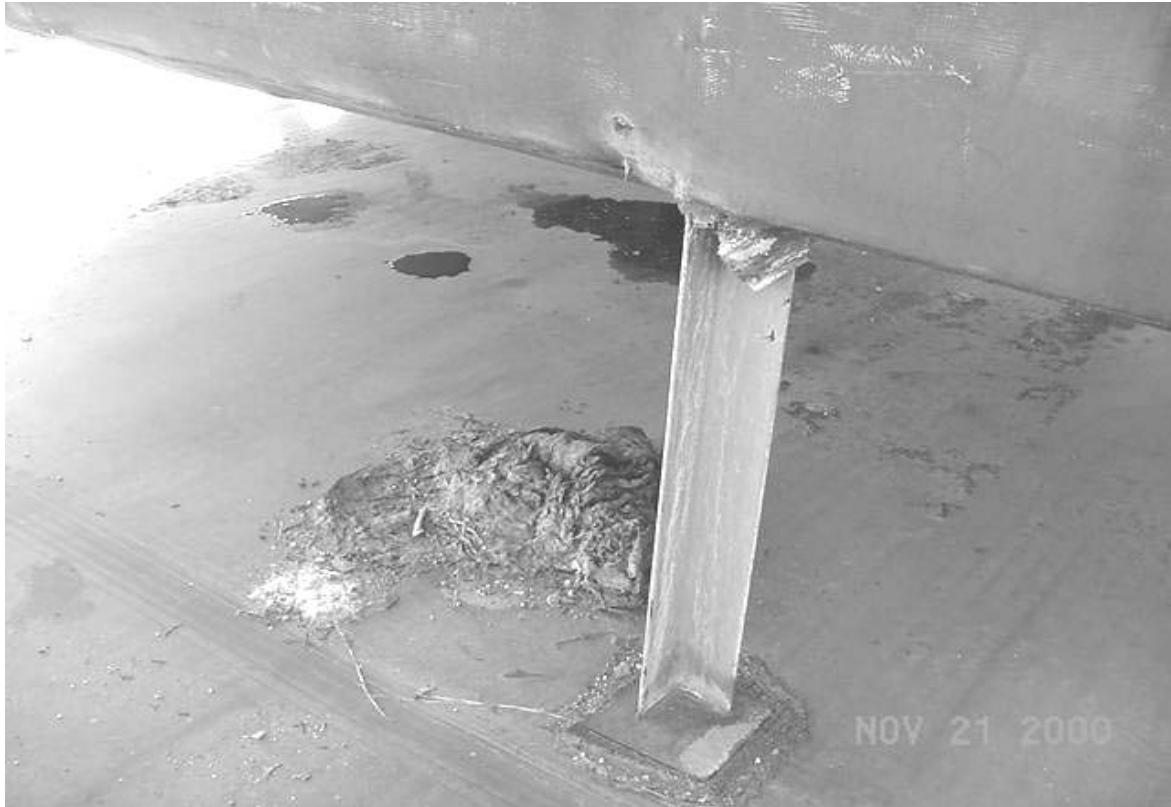
Picture 11

Severe water damage to the fiberglass insulation lining the ductwork may also be a source of microbial exposures. Man made building materials can break down over time or can become mechanically damaged. Under certain conditions, the insulation constituents could become airborne and be distributed to occupied areas via the ventilation system. Fiberglass can also serve as an eye, skin and respiratory irritant.

Accumulated Insulation Material Outside Ductwork

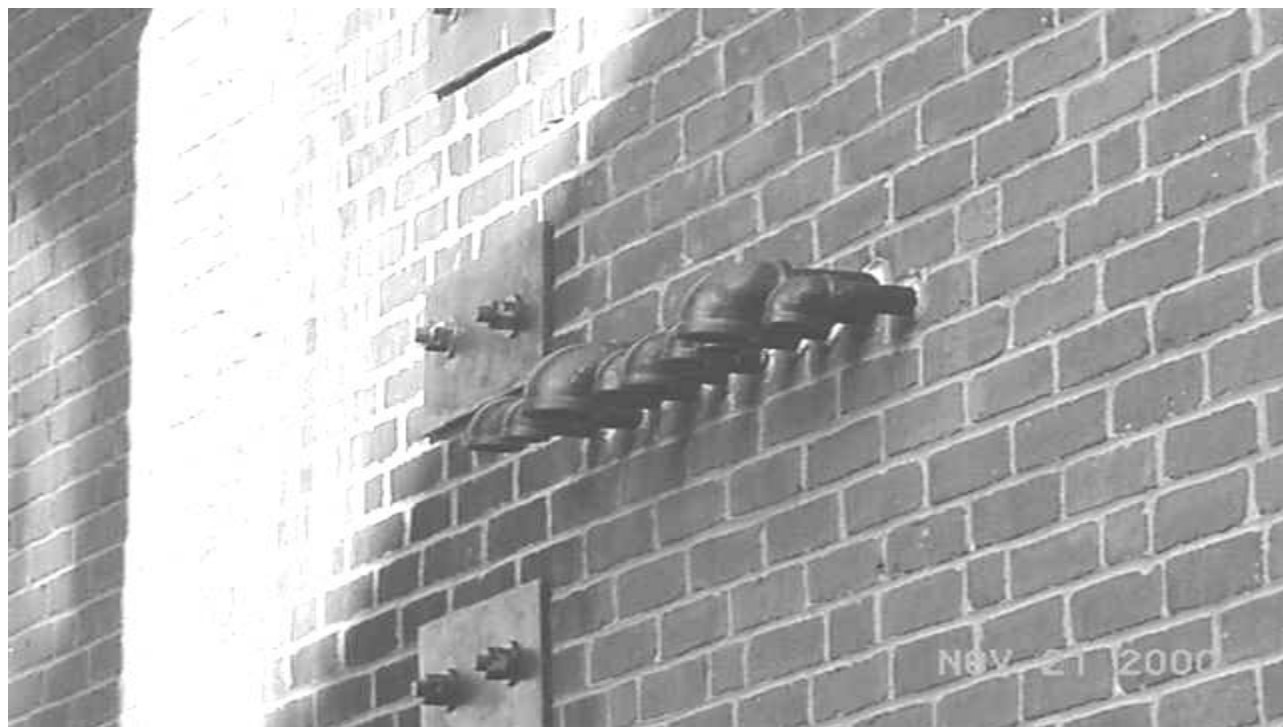
Picture 12

School officials reported a reoccurring problem with exhaust entrainment from the boiler plant located adjacent to the school. Although no odors of exhaust emissions or measurable levels of carbon monoxide were noted indoors by BEHA staff during both site visits, the possibility of entrainment exists. The boilers release emissions from a series of vent pipes approximately 10-15' below the plant roof (see Picture 12). Certain wind and weather conditions can direct boiler exhaust emissions toward and into the open windows or air intakes of the adjacent school building (see Picture 13). Boiler exhaust and wind conditions should be closely monitored to avoid the entrainment of emissions inside the building via open doors, windows and/or AHU fresh air intakes.

Boiler Plant Vent Pipes

- g) Reduce harborages (cardboard boxes) where insects may reside.
- 15) Close classroom windows and doors adjacent to the boiler plant during wind/weather conditions conducive for the entrainment of exhaust odors. Consider extension of the boiler exhaust vent pipes if problem persists.

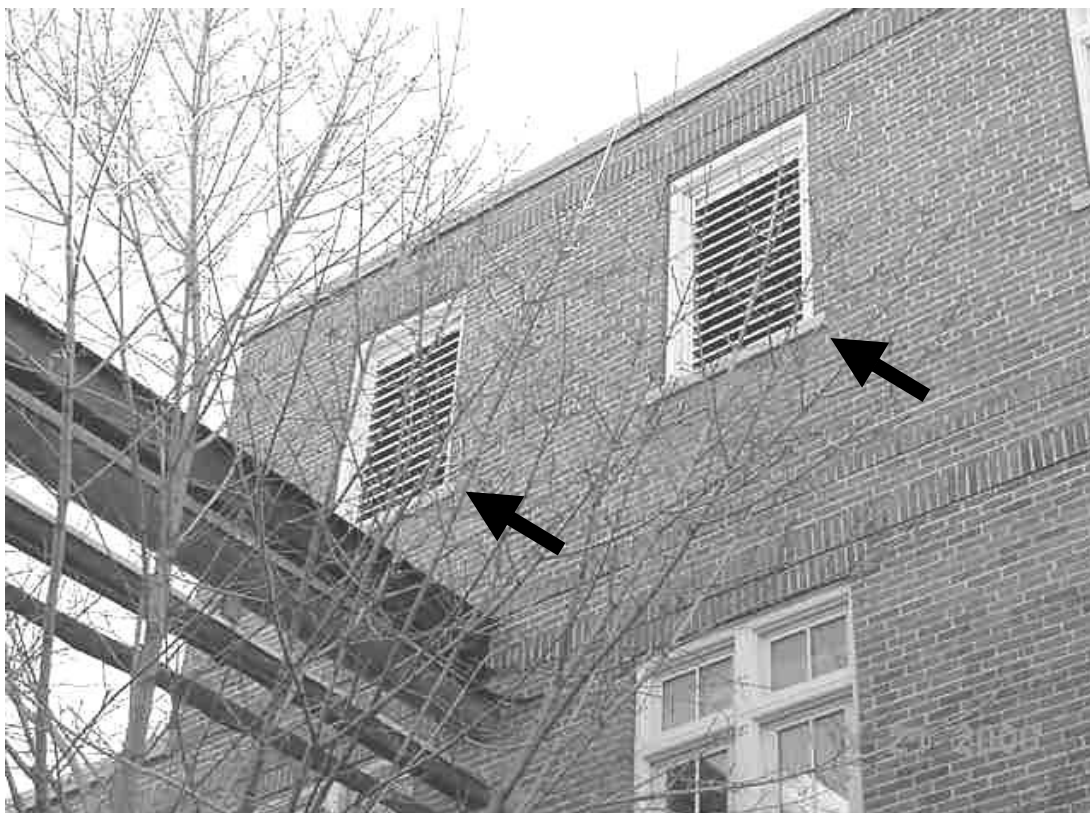
Picture 13

Air Intakes for AHU Adjacent to Boiler Plant

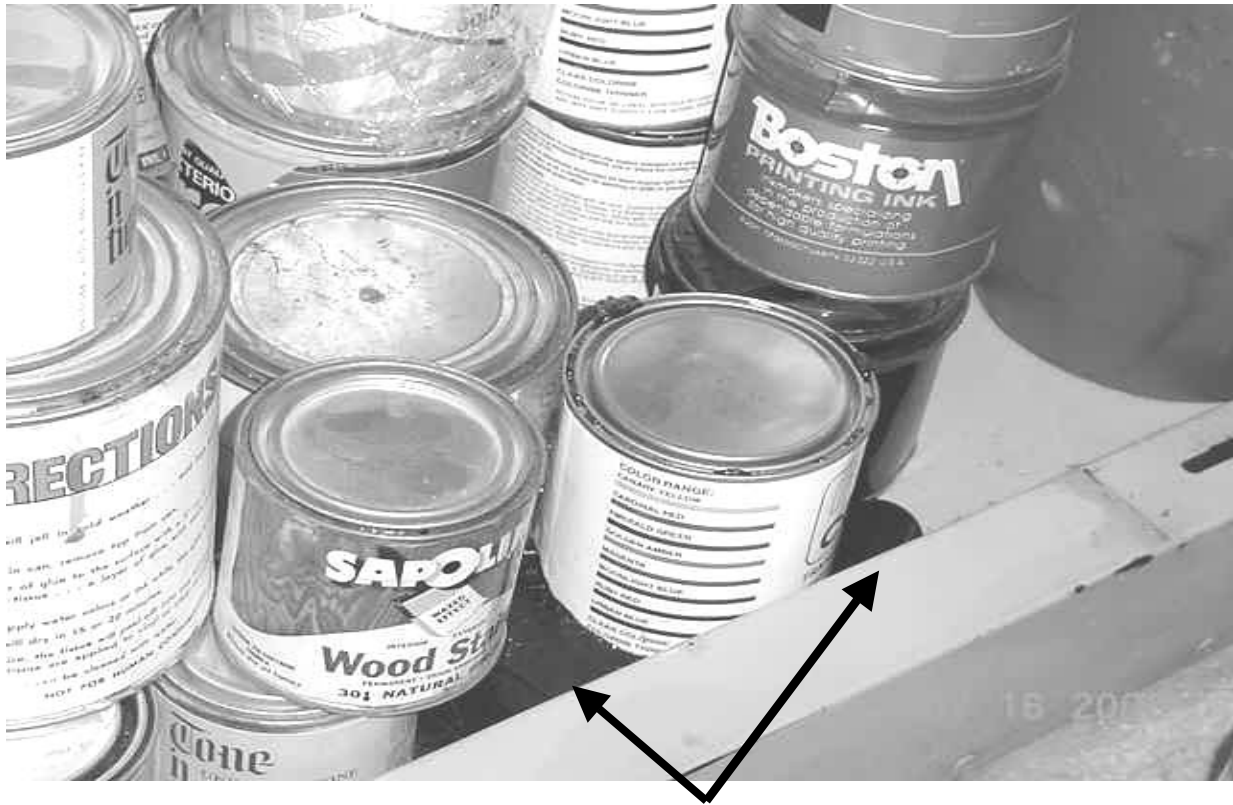
Picture 14

Classroom 303 had a 1-gallon container of paint thinner in the cabinet under the sink; classrooms 201 & 203 contained spray cans of graffiti remover. The art room had a 1-gallon container of paint thinner stored on top of a flammables cabinet. Strong chemical odors were noted upon opening the flammable cabinet. BEHA staff observed a thick, dark substance spilled on the bottom of the cabinet (see Picture 14), which appeared to be the most likely source of odors. Paint thinners, certain art supplies and other flammable materials contain VOCs which can cause eye, throat and respiratory irritation. In addition, flammable materials found in classrooms should be stored in a storage cabinet that meets design criteria set forth by the National Fire Protection Association (NFPA, 1996).

Interior of Art Room (300) Flammable Cabinet Note Dark Material Spilled at Bottom of Cabinet

- 12) Determine the identification of spilled substance in the flammable storage cabinet of art room 300 and obtain MSDS. Clean up spill in accordance with the MSDS sheet using appropriate health and safety precautions.

- 13) Store flammable materials in flameproof cabinets consistent with local and state fire codes.
 - 14) It is highly recommended that the principles of integrated pest management (IPM) be used to rid this building of pests. As previously noted, a copy of the
